TEST REPORT
FOR
MSFC TEST NO. 83- 3

WATER IMPACT TEST OF AFT SKIRT
END RING, AND MID RING SEGMENTS OF
THE SPACE SHUTTLE SOLID ROCKET BOOSTER

TECHNICAL NOTE

CONTRACT NAS8-35017

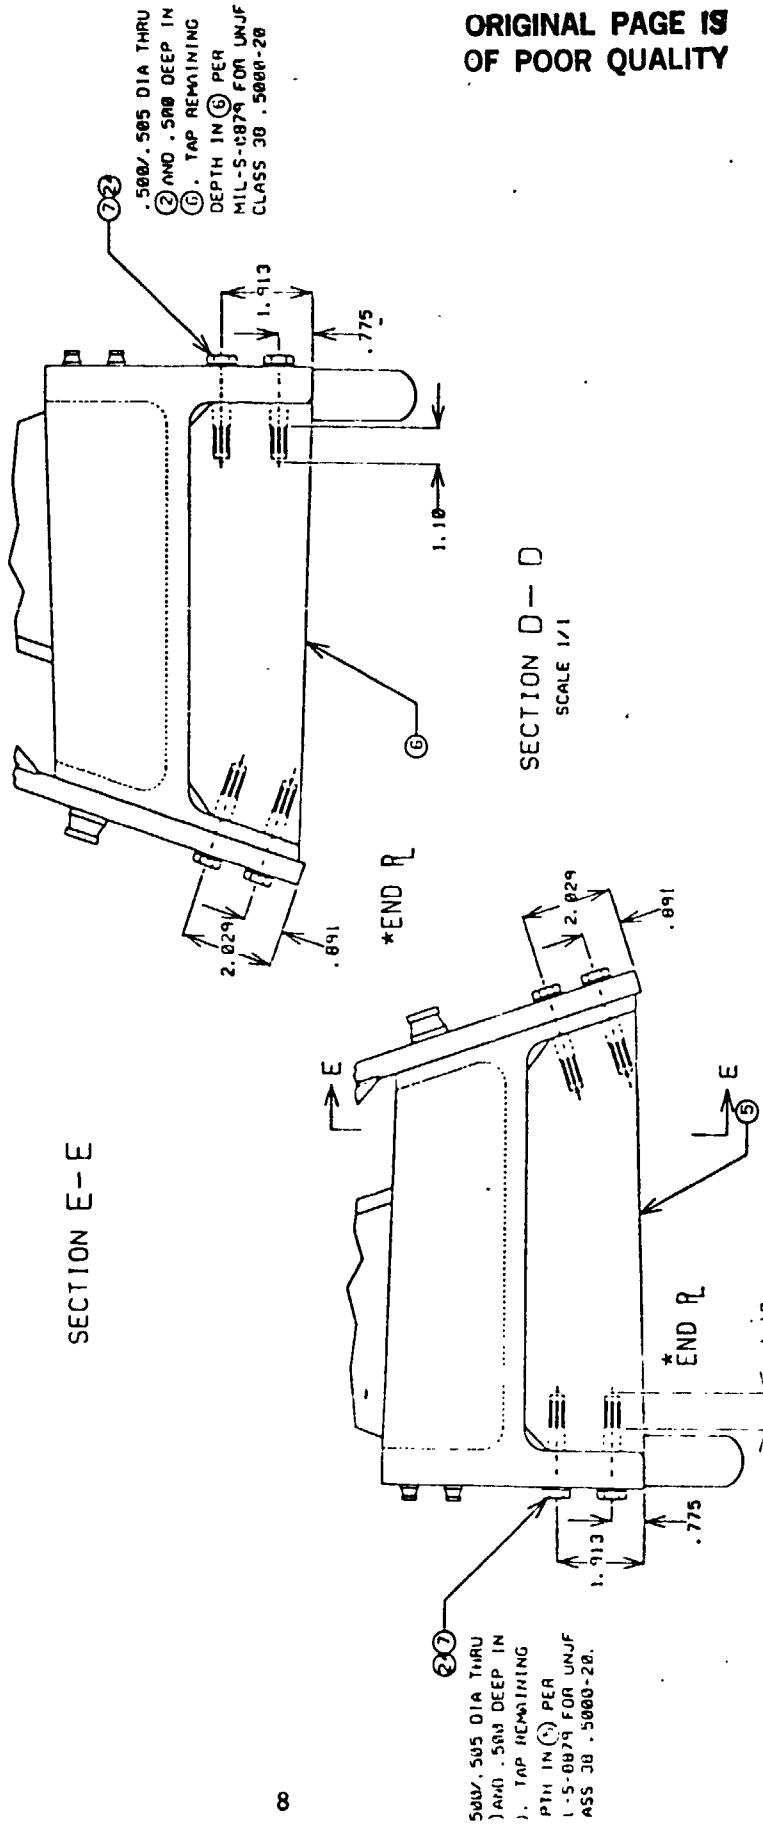
Figure 4 - Aft Ring Segment Model Details

*NOTE: END PLATES WERE NOT USED IN THIS TEST

The first model used for the test program was an aft skirt end ring segment (approx. 30 degree segment) simulation of the STS-5 configuration. It consists of 52" wide, 38" long, and 0.5" thick flat skin panel with (6) stringers, (after machining) skirt aft ring, gussets, closeout plates, and adapter base as illustrated in Figures 1 thru 5. This model configuration was varied as noted in this text. The baseline mass characteristics were;

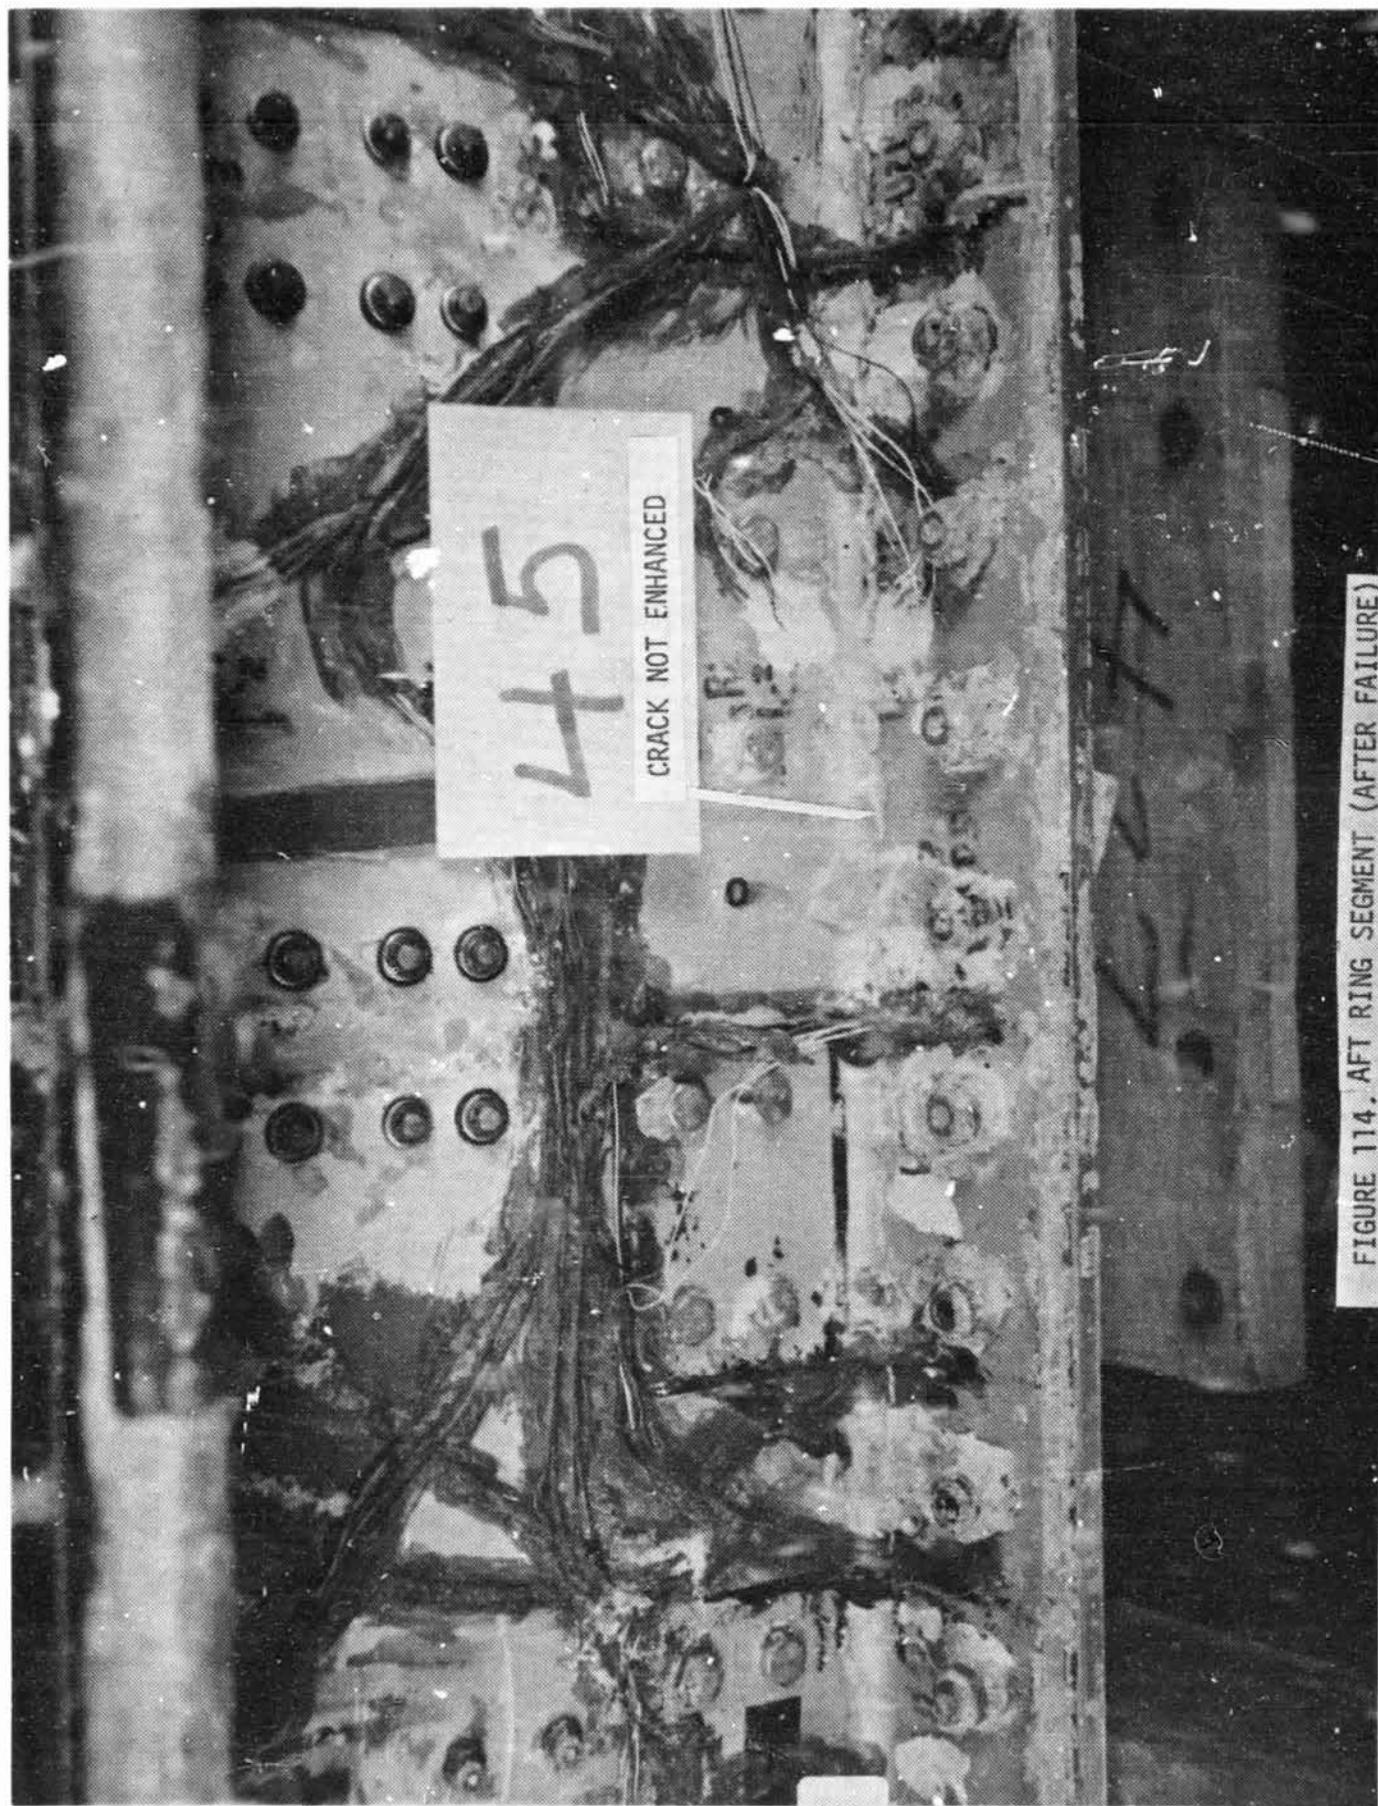
FIGURE 114. AFT RING SEGMENT (AFTER FAILURE)

CRACK ENHANCED WITH BLACK INK
